Structural Safety Inspection Report

Factory Name	Jericho Imex Ltd
Accord ID	9414
Factory Address	DAG NO. 1/20 & 330, MONTRIKIRI ROAD, SOUTH SHALNA, SHALNA BAZAR, CAZIBUR 1703
Date of Initial Inspection	20-Sep-2016
Date of Review Inspection	19-Mar-2020
Inspected by	Md. Abu Zafar-Al-Mansur

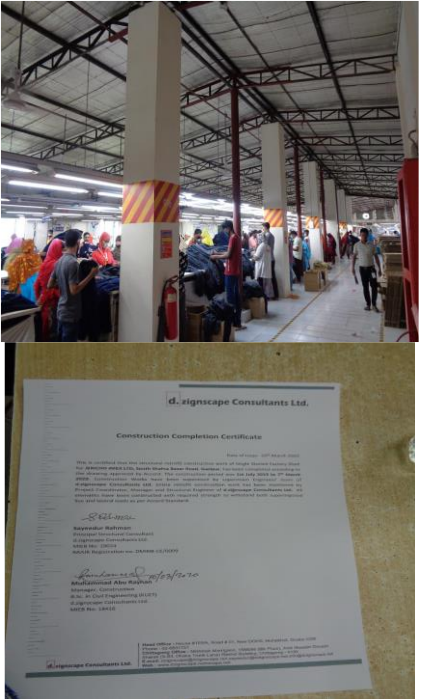
Item No	Accord Observation	Accord Recommendation	Accord Timeline	Final Action Plan	Final Timeline(dd-mm-yyyy)	Comments after Physical Inspection	Progress Status	Pictorial Evidence
3	Lack of lateral stability observed.	Carry out all recommendations of the Engineering Assessment.	within 6-months	Done	16-Mar-2019	<p>On 7-Nov-17: Factory has submitted EA report to Accord. Some revisions are required which is need to be submit within 16/11/2017. This issue will be corrected after completion of remediation work as per EA recommendation.</p> <p>On 27-May 2018: EA has been carried out and submitted to Accord .As per review comment sent by Accord ,factory is required to submit revised EA within 28th May 2018.Factory is required to carry out remedial works as per recommendations from accepted EA .</p> <p>On 23-Apr-2019: This issue is required to be covered under EA. EA has been produced and submitted(12th Submission) to Accord on 14th Feb 2019. Review comments were sent on submitted EA on 9th Apr 2019. As per review comments, factory is required to submit revised EA within 6th May 2019. Factory is required to carry out remedial works(if any) as per recommendation from accepted EA.</p> <p>On 30-October-2019: This issue had been covered in EA report. Factory management got EA acceptance from ACCORD on 29-May-2019. As per recommendation of EA retrofitting works were required to be completed within 31-August-2019. But during inspection retrofitting works were found ongoing (steel part completed but 2 nos. RC column retrofitting pending).</p> <p>On 19th March 2020: Factory has completed all retrofitting works in Factory Shed as per accepted retrofitting drawing. Retrofitting completion certificate has also been provided by the factory consultant.</p>	Corrected

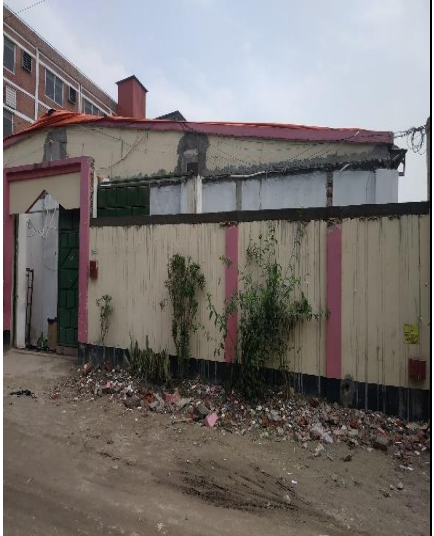
Item No	Accord Observation	Accord Recommendation	Accord Timeline	Final Action Plan	Final Timeline(dd-mm-yyyy)	Comments after Physical Inspection	Progress Status	Pictorial Evidence
4	Non-Engineered Lightweight steel structures.	Engage a qualified structural engineer to confirm satisfactory structural performance of the buildings under wind loading.	within 6-weeks	Done	16-Mar-2019	<p>On 7-Nov-17: Factory has submitted EA report to Accord. Some revisions are required which is need to be submit within 16/11/2017. This issue will cover in EA.</p> <p>On 27-May 2018: Structural performance under wind loading was checked in EA.EA has been submitted to Accord .As per review mail ,factory is required to submit revised EA within 28th May 2018.</p> <p>On 23-Apr-2019: This issue is required to be covered under EA. EA has been produced and submitted(12th Submission) to Accord on 14th Feb 2019. Review comments were sent on submitted EA on 9th Apr 2019. As per review comments, factory is required to submit revised EA within 6th May 2019.</p> <p>On 30-October-2019: This issue had been covered in EA report. Factory management got EA acceptance from ACCORD on 29-May-2019. As per recommendation of EA, non-engineered lightweight steel structure at roof was required to be demolished within 31-August-2019. But during inspection it was found that demolishing work not started yet.</p> <p>On 19th March 2020: Factory has demolished all non engineered Steel structures.</p>	Corrected

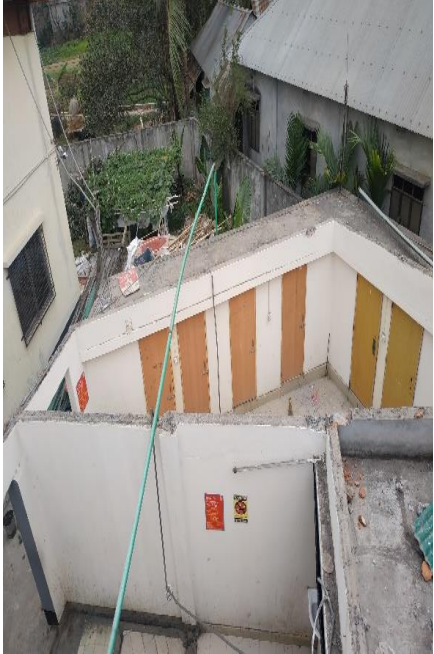
Item No	Accord Observation	Accord Recommendation	Accord Timeline	Final Action Plan	Final Timeline(dd-mm-yyyy)	Comments after Physical Inspection	Progress Status	Pictorial Evidence
5	Non-Engineered Lightweight steel structures.	Remedial works to be carried out if required.	within 6-months	Done	16-Mar-2019	<p>On 7-Nov-17: Factory has submitted EA report to Accord. Some revisions are required which is need to be submit within 16/11/2017. This issue will be corrected after completion of remediation work as per EA recommendation.</p> <p>On 27-May 2018: Non engineered light weight steel structures were incorporated in EA.EA has been submitted to Accord .As per review mail ,factory is required to submit revised EA within 28th May 2018.Factory is required to carry out remedial works as per recommendations from accepted EA .</p> <p>On 23-Apr-2019: This issue is required to be covered under EA. EA has been produced and submitted(12th Submission) to Accord on 14th Feb 2019. Review comments were sent on submitted EA on 9th Apr 2019. As per review comments, factory is required to submit revised EA within 6th May 2019. Factory is required to carry out remedial works(if any) as per recommendation from accepted EA.</p> <p>On 30-October-2019: This issue had been covered in EA report. Factory management got EA acceptance from ACCORD on 29-May-2019. As per recommendation of EA, non-engineered lightweight steel structure at roof was required to be demolished within 31-August-2019. But during inspection it was found that demolishing work not started yet.</p> <p>On 19th March 2020: Factory has demolished all non engineered Steel structures.</p>	Corrected

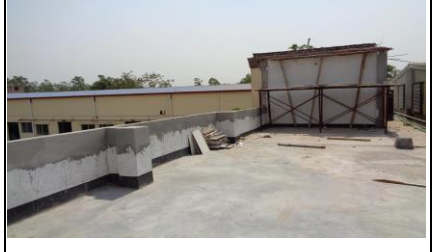
6	Falling hazards on the roof & water ponding and protect reinforcement & steel member from corrosion.	Provide immediate edge protection to the roof.	Immediate - Now	Done	23-Dec-2016	<p>On 7-Nov-17: Factory did not provide any edge protection to the roof</p> <p>On 27-May 2018: Edge protection was provided on roof .</p> <p>On 23-Apr-2019: This issue is corrected in previous follow-up inspection.</p> <p>On 30-October-2019: Corrected in previous follow up inspection. Factory management had provided edge protection on roof.</p> <p>On 19th March 2020: Corrected from previous inspection. Factory has provided parapet at roof level.</p>	Corrected

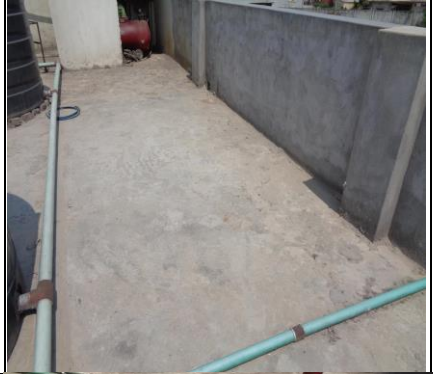
Item No	Accord Observation	Accord Recommendation	Accord Timeline	Final Action Plan	Final Timeline(dd-mm-yyyy)	Comments after Physical Inspection	Progress Status	Pictorial Evidence
7	Falling hazards on the roof & water ponding and protect reinforcement & steel member from corrosion.	Factory engineer to identify the cause of water ponding & suggest appropriate remedial action.	within 6-weeks	Done	17-Dec-2016	<p>On 7-Nov-17: They have not provided water proofing layer at the roof top to protect water intrusion into the slab. No water ponding found during inspection.</p> <p>On 27-May 2018: Water proofing was not provided on rooftop .Factory is required to provide water proofing with sufficient slope .</p> <p>On 23-Apr-2019: No water ponding was observed during inspection. Water proofing has been applied on rooftop. Drainage system has been also provided.</p> <p>On 30-October-2019: Corrected in previous follow up inspection. Water proofing had been applied on rooftop. Water ponding was not observed during inspection.</p> <p>On 19th March 2020: Corrected from previous inspection. factory has improved drainage system and during inspection no water ponding was found.</p>	Corrected

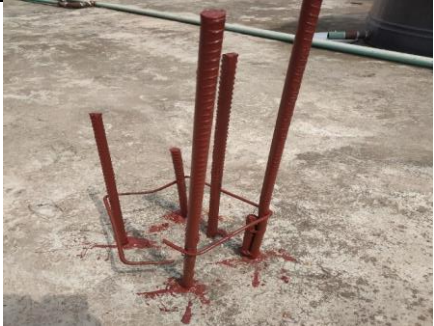
8	Falling hazards on the roof & water ponding and protect reinforcement & steel member from corrosion.	All exposed reinforcement is to be protected from corrosion which may cause degradation of the concrete.	within 6-weeks	Done	17-Dec-2016	<p>On 7-Nov-17: All exposed reinforcements are found coated with color.</p> <p>On 27-May 2018: This issue is corrected in previous follow-up inspection .Exposed reinforcement was painted .</p> <p>On 23-Apr-2019: This issue is corrected in 1st follow-up inspection. All rooftop exposed reinforcements has been coated with paint.</p> <p>On 30-October-2019: Corrected in previous follow up inspection. Exposed rebar were found coated with paint.</p> <p>On 19th March 2020: Corrected from previous inspection. All exposed rebar were found coated with paint.</p>	Corrected
